COASTAL GEOLOGIC HAZARDS AND COASTAL TECTONICS

NORTHERN MONTEREY BAY AND
SANTA CRUZ/SAN MATEO COUNTY COASTLINES

GARY B. GRIGGS
GERALD E. WEBER

ASSOCIATION OF ENGINEERING GEOLOGISTS
MARCH 3, 1990

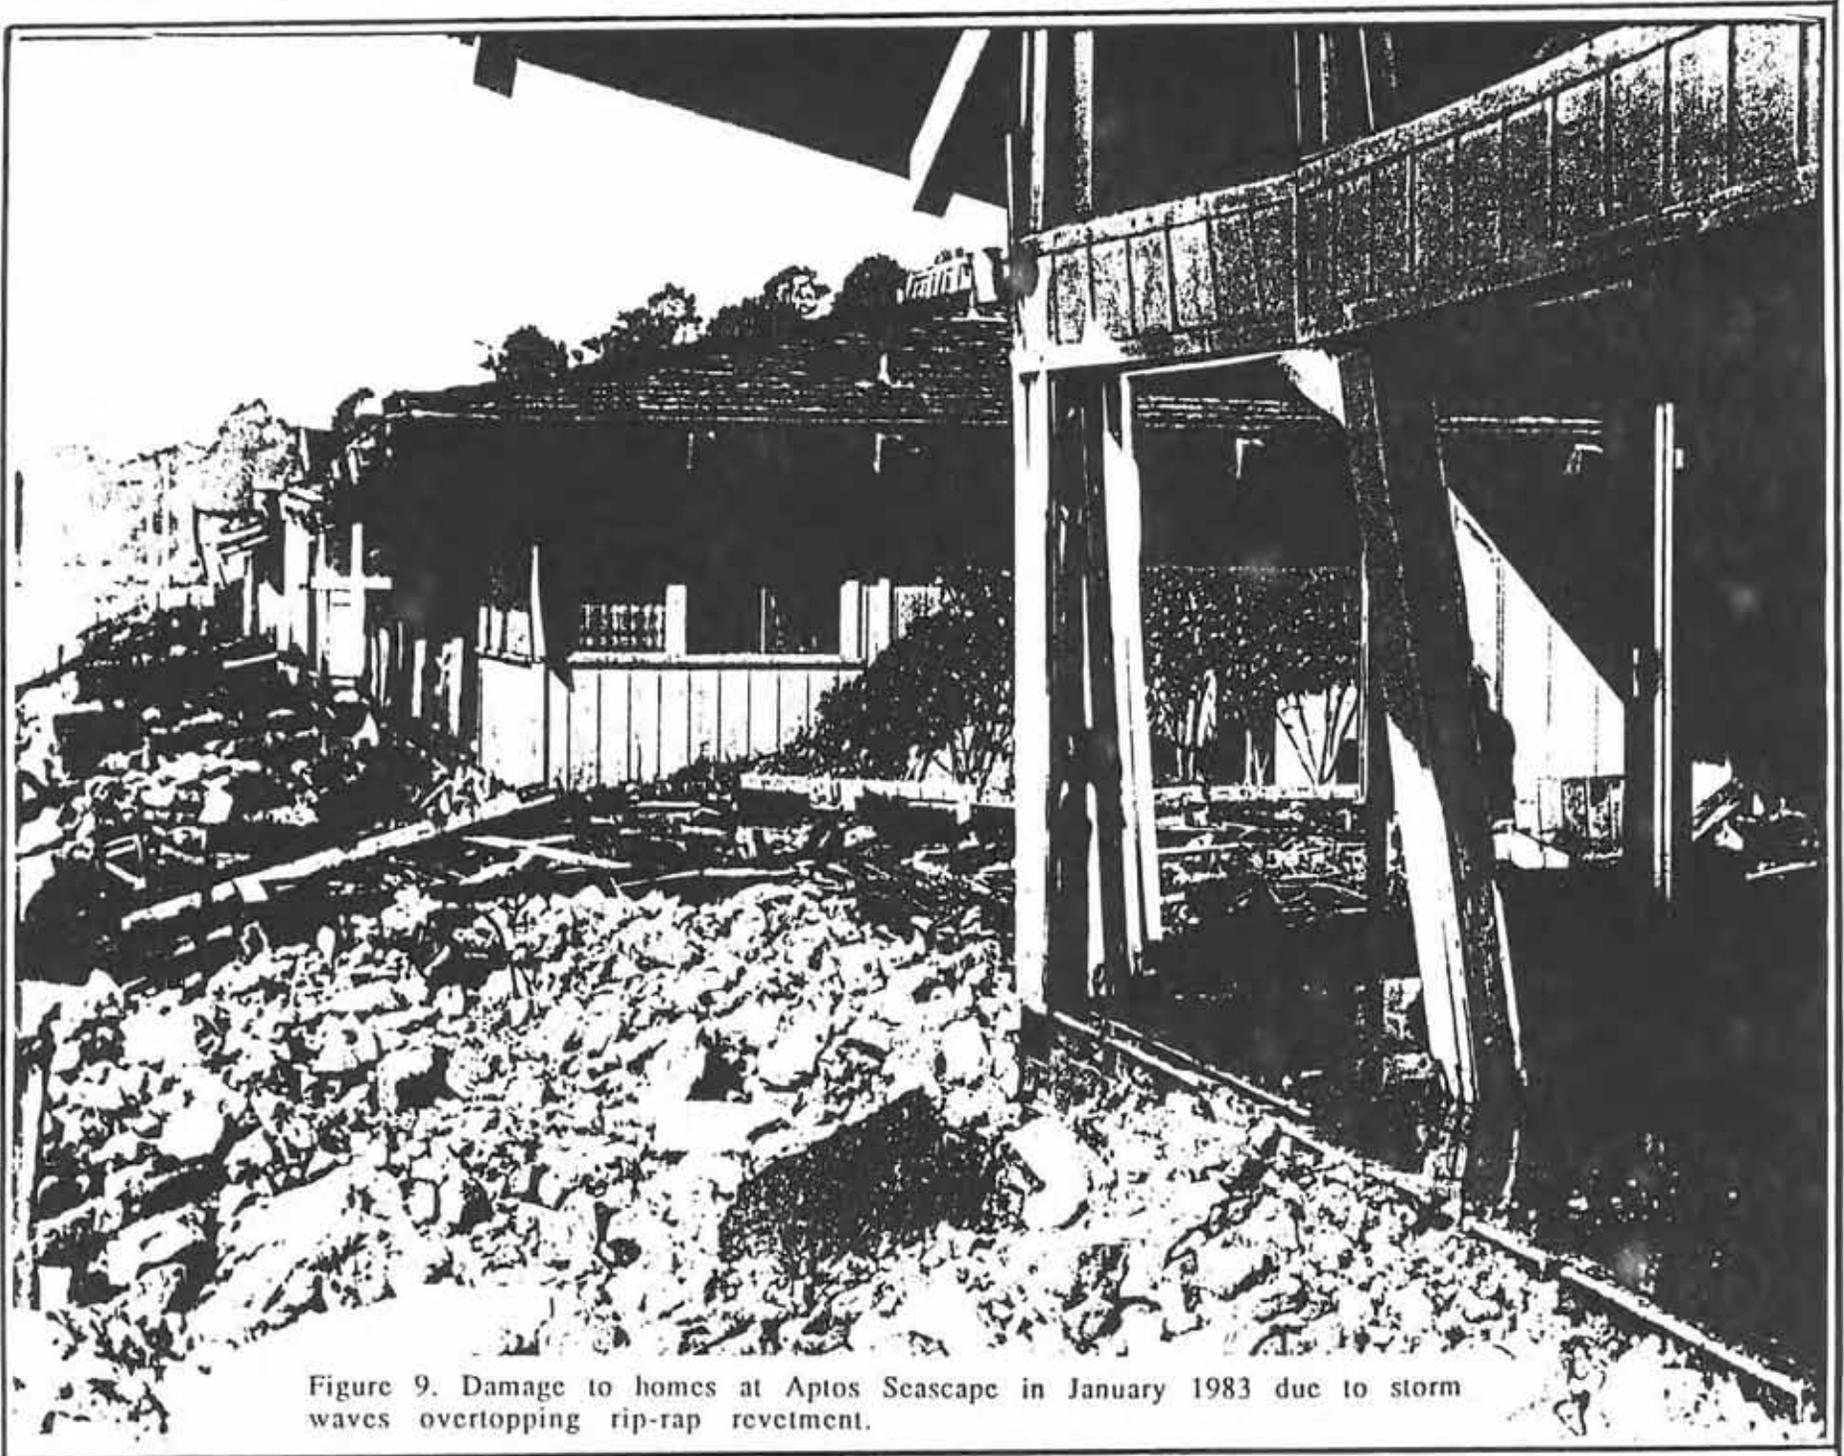
Figure 9. Damage to homes at Aptos Seascapes in January 1983 due to storm waves overtopping rip-rap revetment.

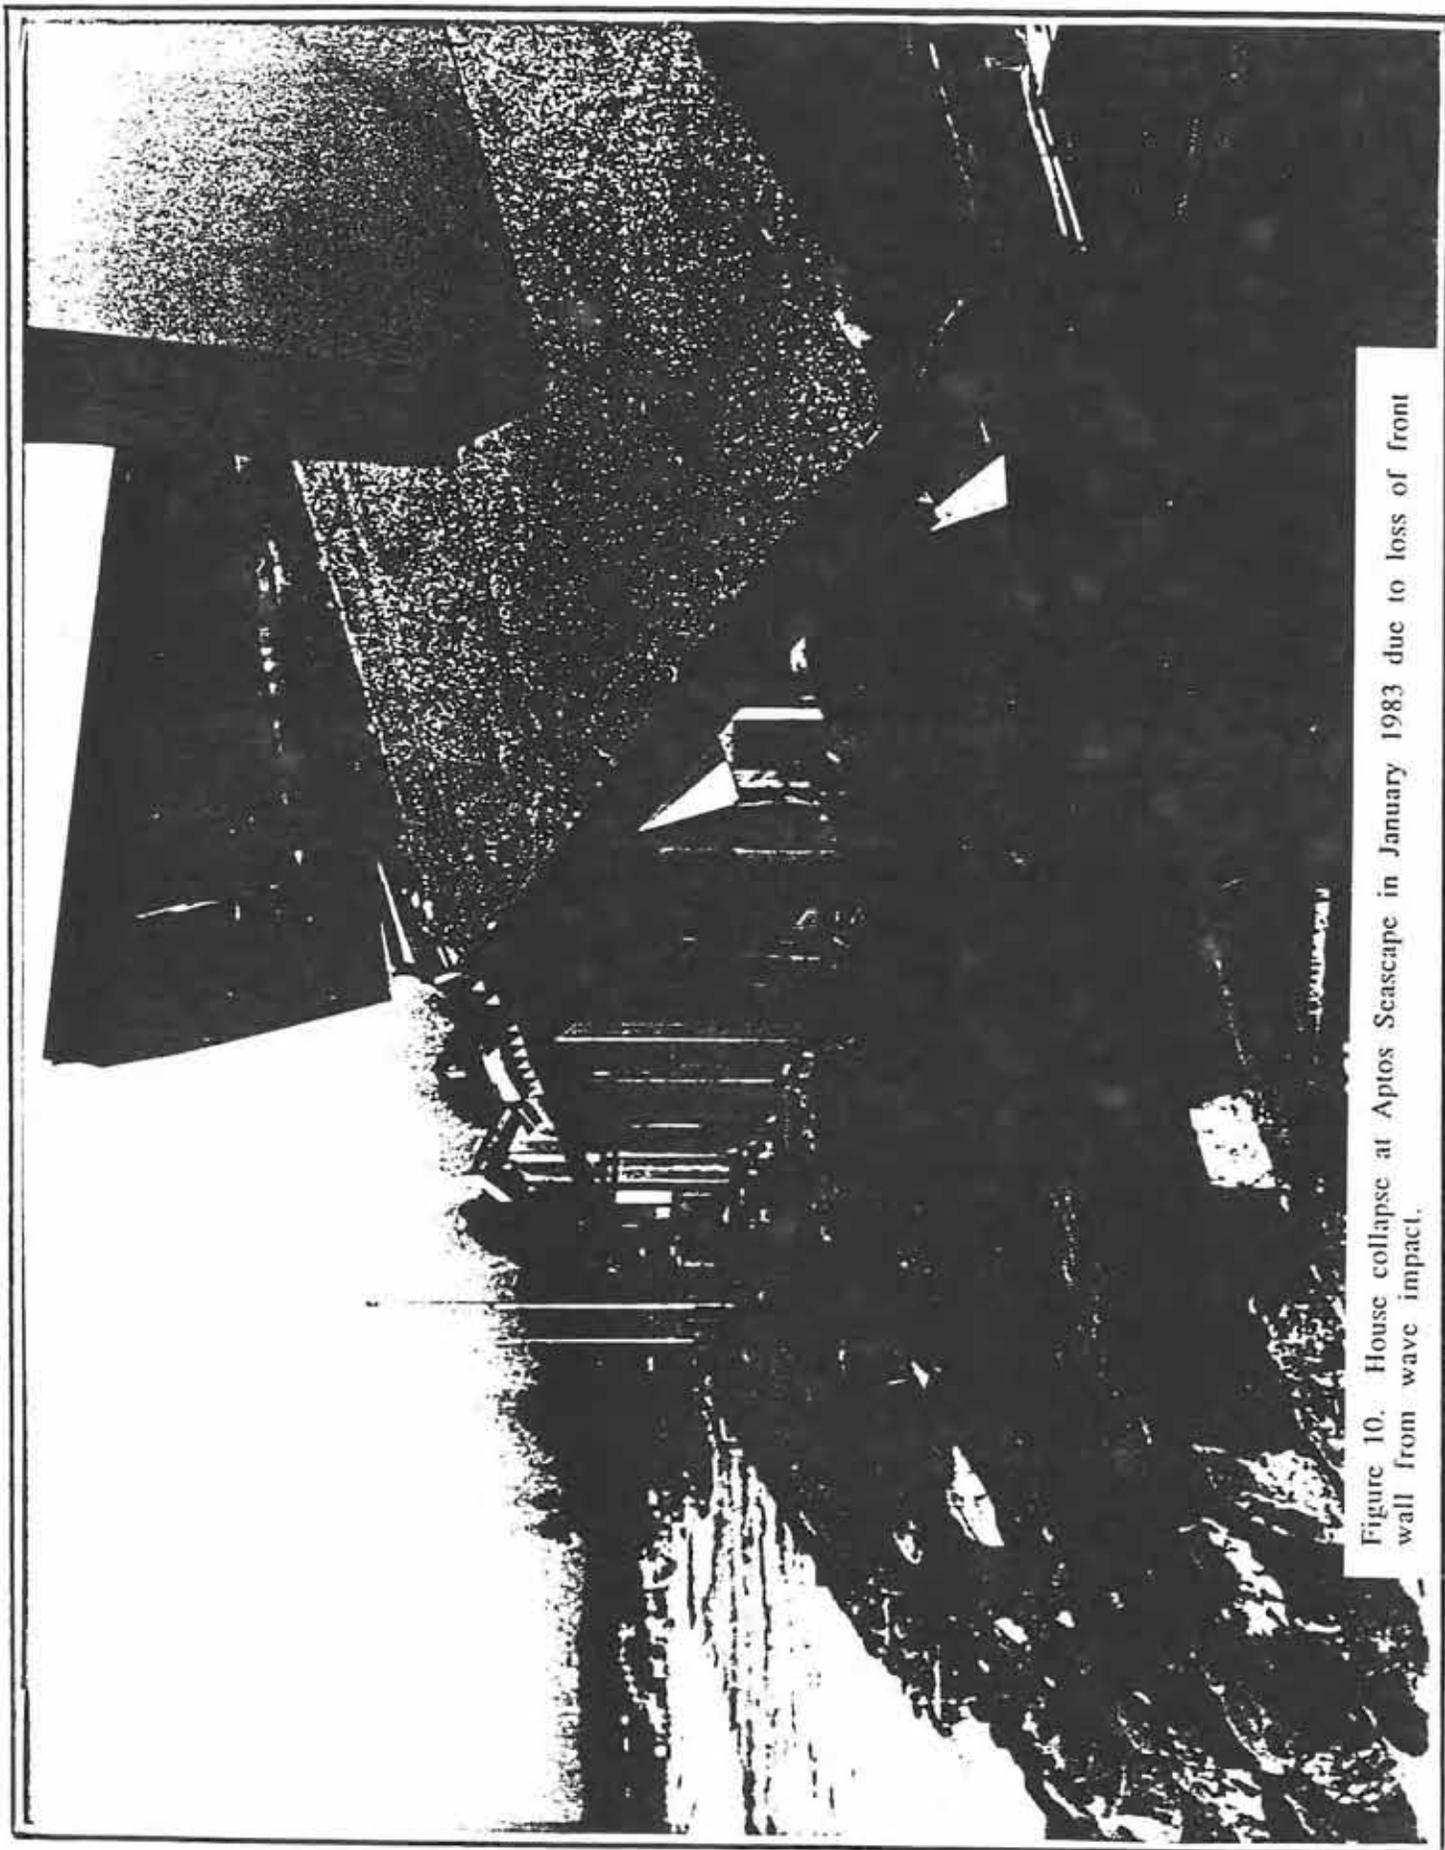
Figure 10. House collapse at Aptos Scenic in January 1983 due to loss of front wall from wave impact.

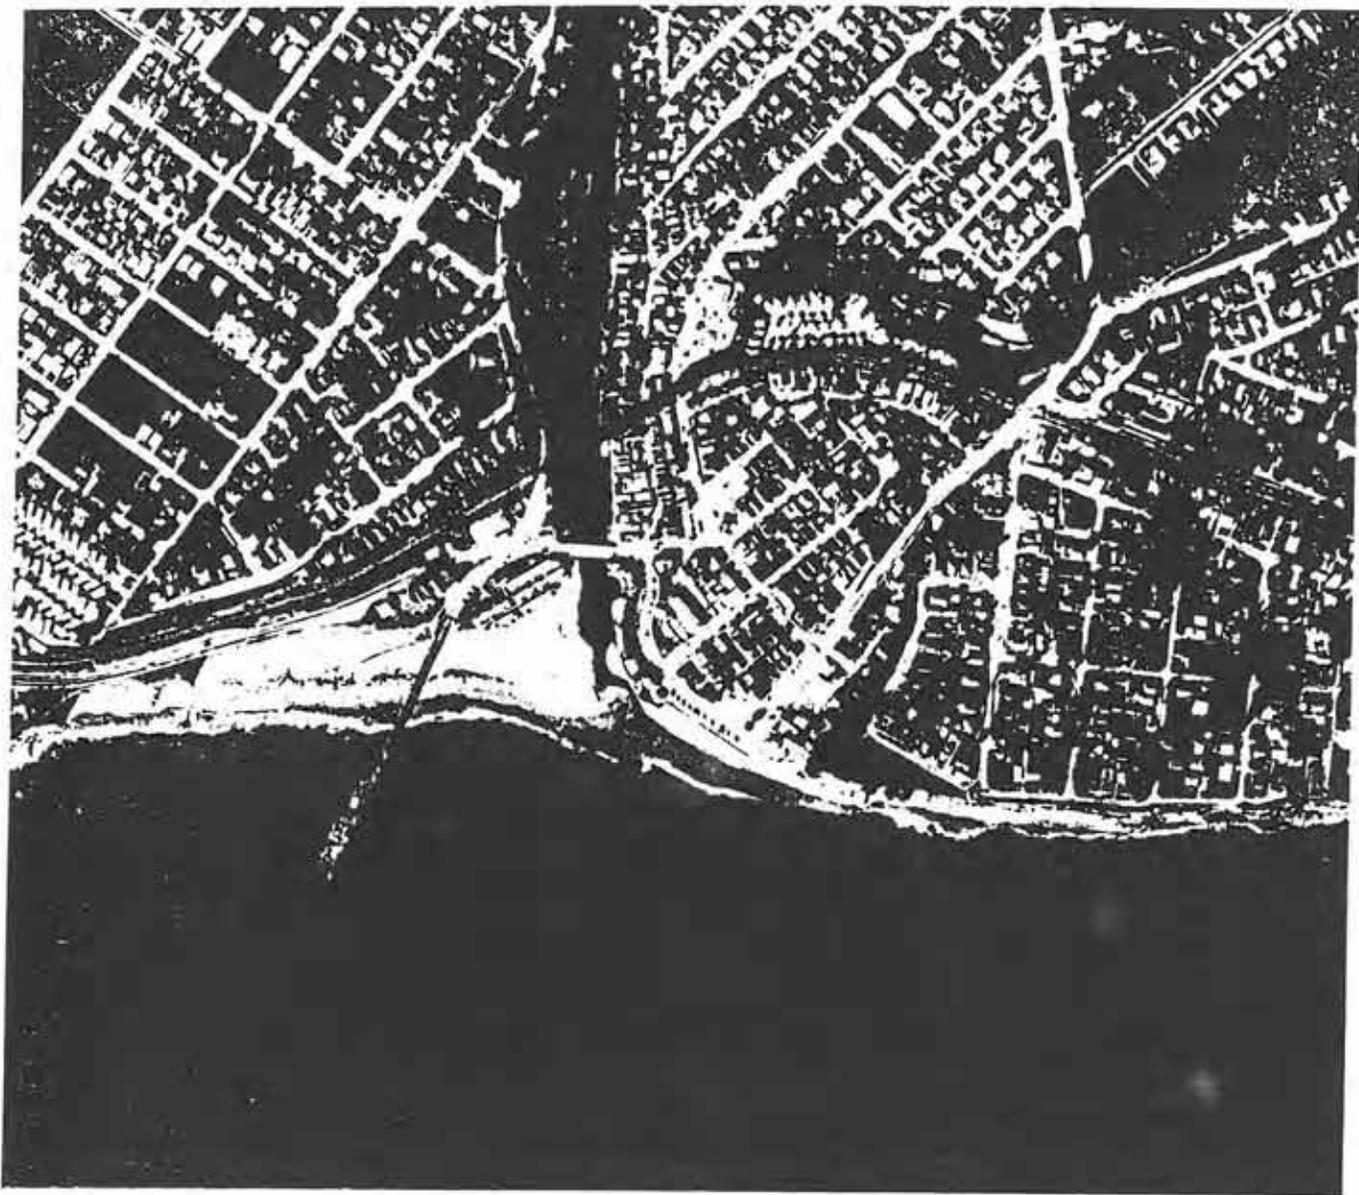
Figure 1. Capitola Beach in December 1961 prior to harbor construction at Santa Cruz.

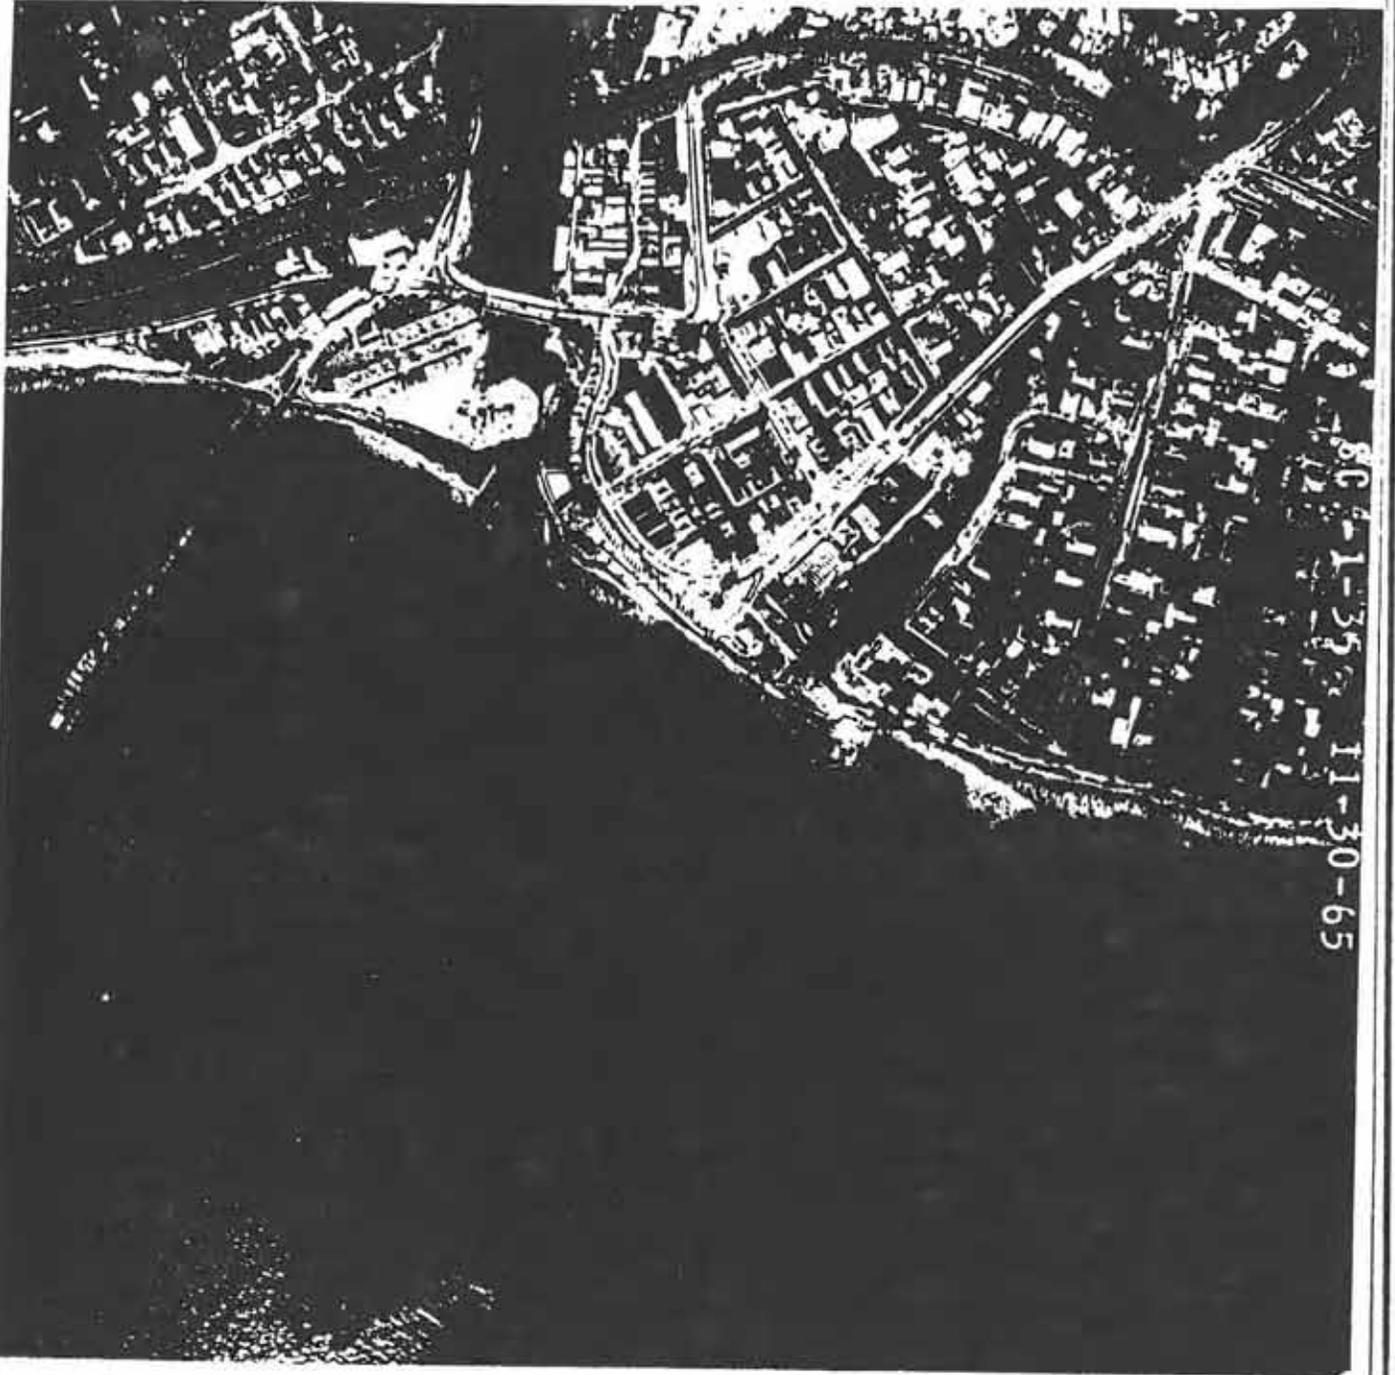
Figure 2. Capitola Beach in November 1965 following construction of the harbor at Santa Cruz.

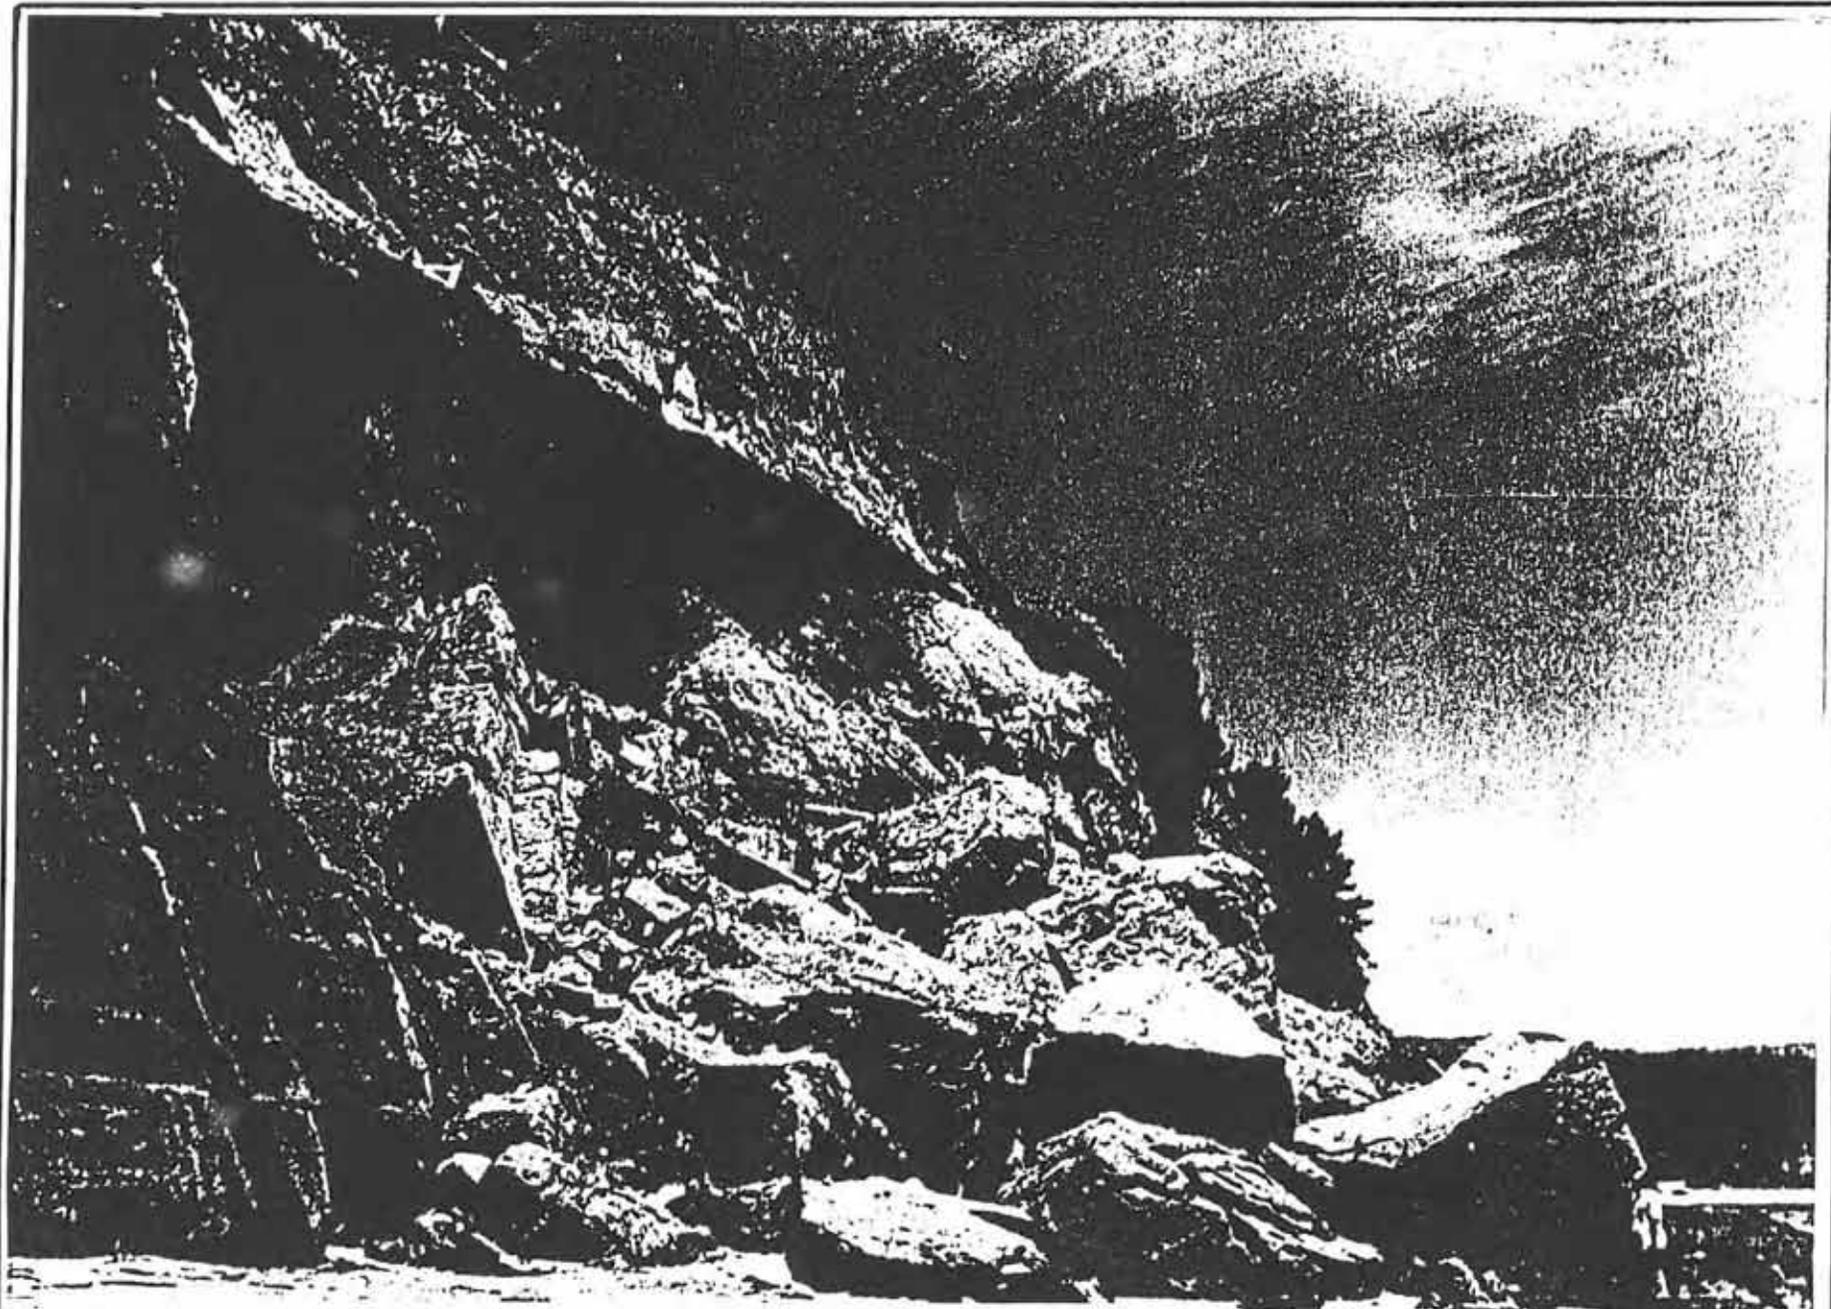
Figure 5. Large blocks of sandstone, siltstone, and mudstone commonly break loose from the bluffs at Capitola along intersecting joint sets and fall to the beach below.

The typical failure mode is through marine erosion of the weak units exposed at the base of the cliff. When the sand levels drop and expose this notch, support is partially lost for the overlying joint bounded blocks which then topple to the beach (Figure 5). As recently as the summer of 1987, large blocks 6 to 9 feet in width and up to 20 feet in alongshore length, toppled to the beach below. This same type of failure extends all the way to New Brighton Beach where the shoreline orientation changes and a wide stable beach appears.

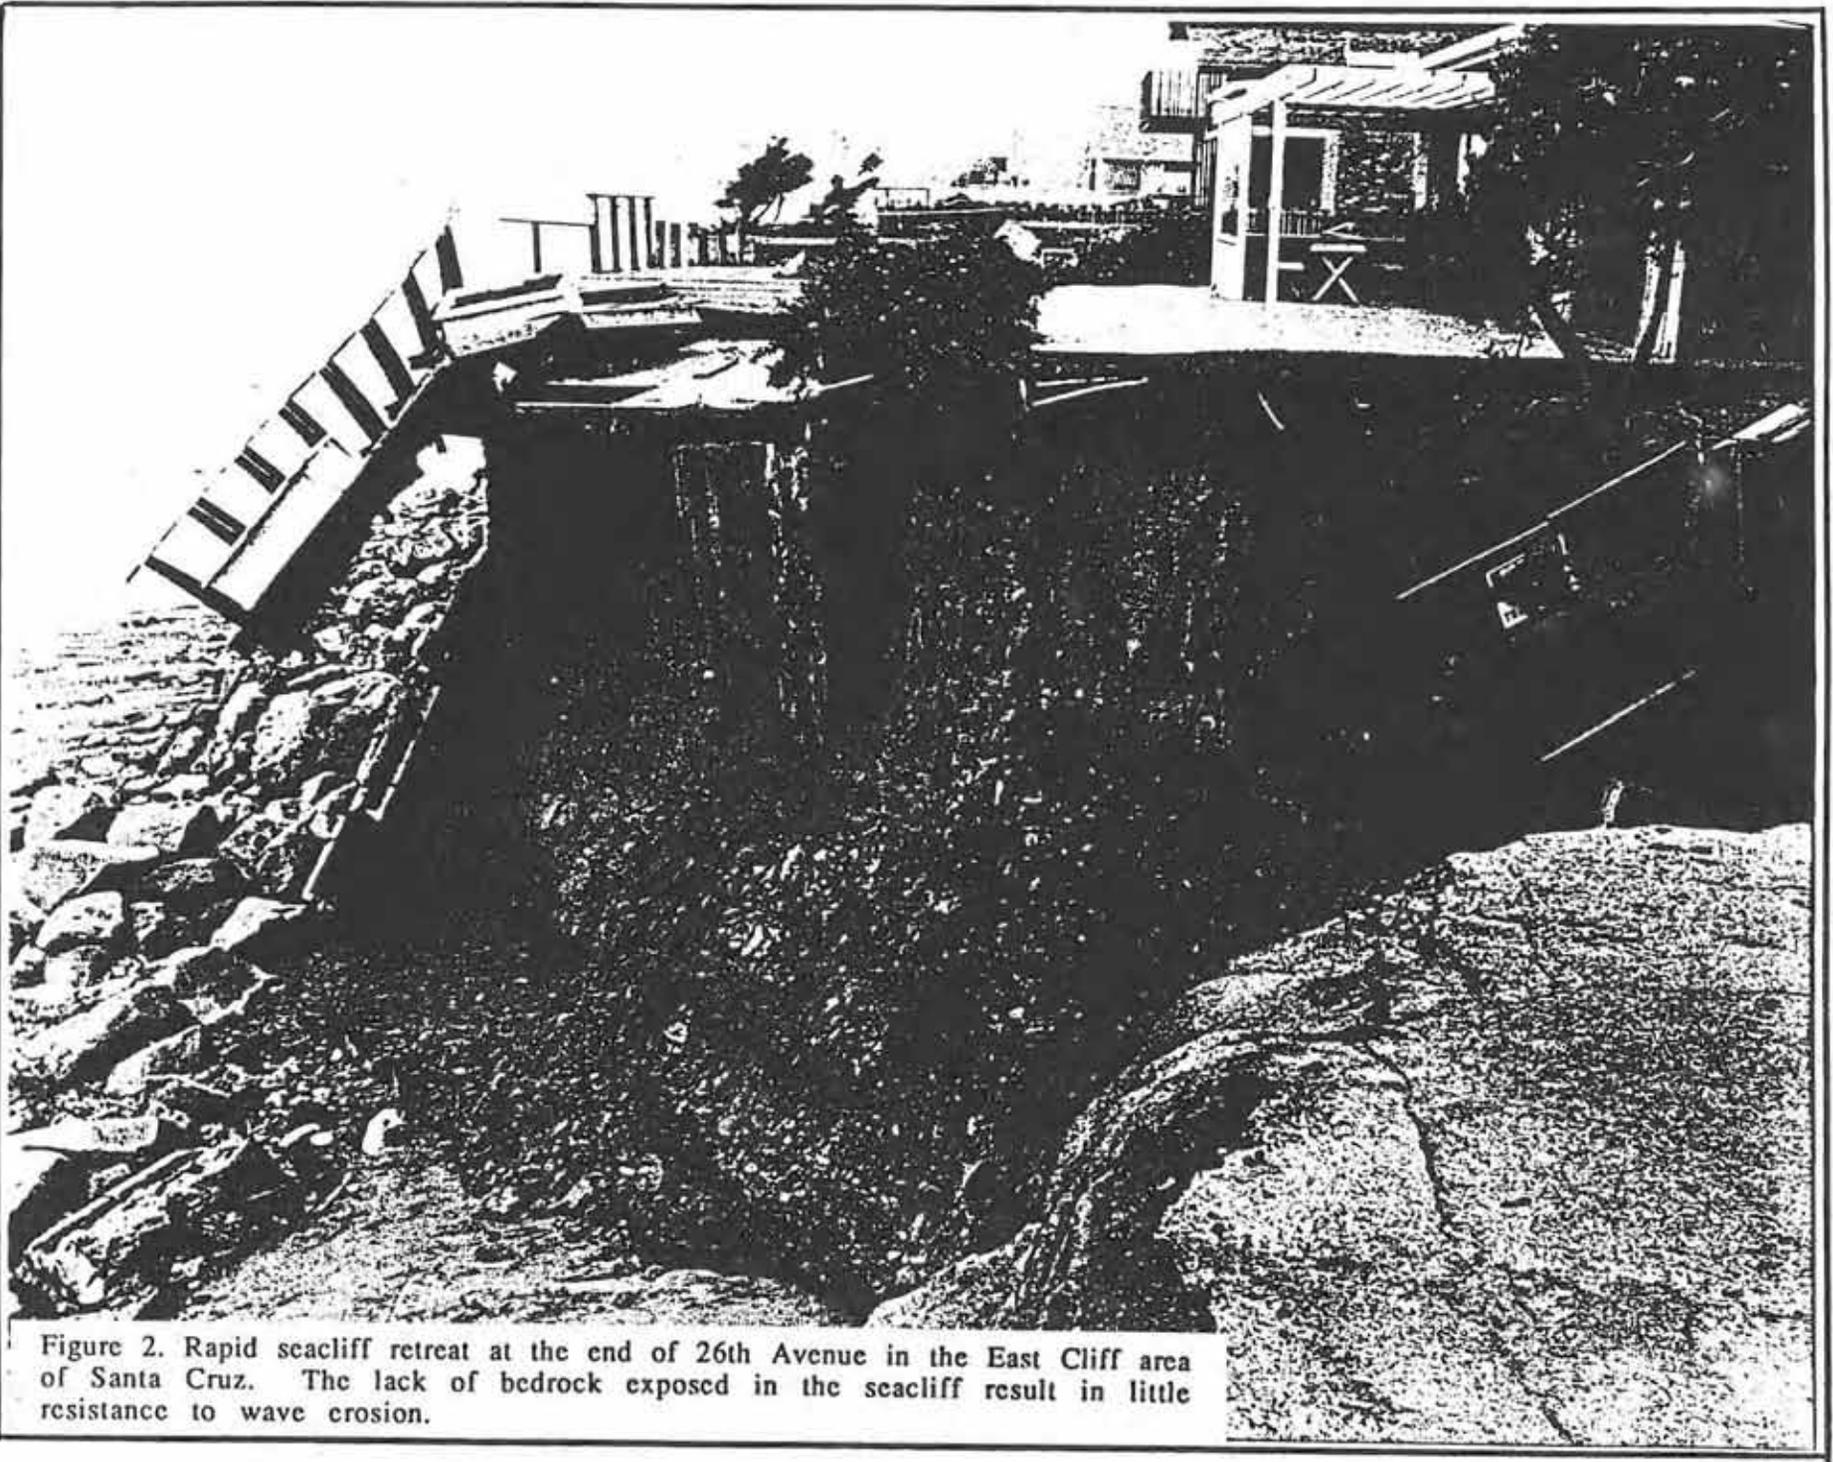
Figure 2. Rapid seacliff retreat at the end of 26th Avenue in the East Cliff area of Santa Cruz. The lack of bedrock exposed in the seacliff result in little resistance to wave crosion.

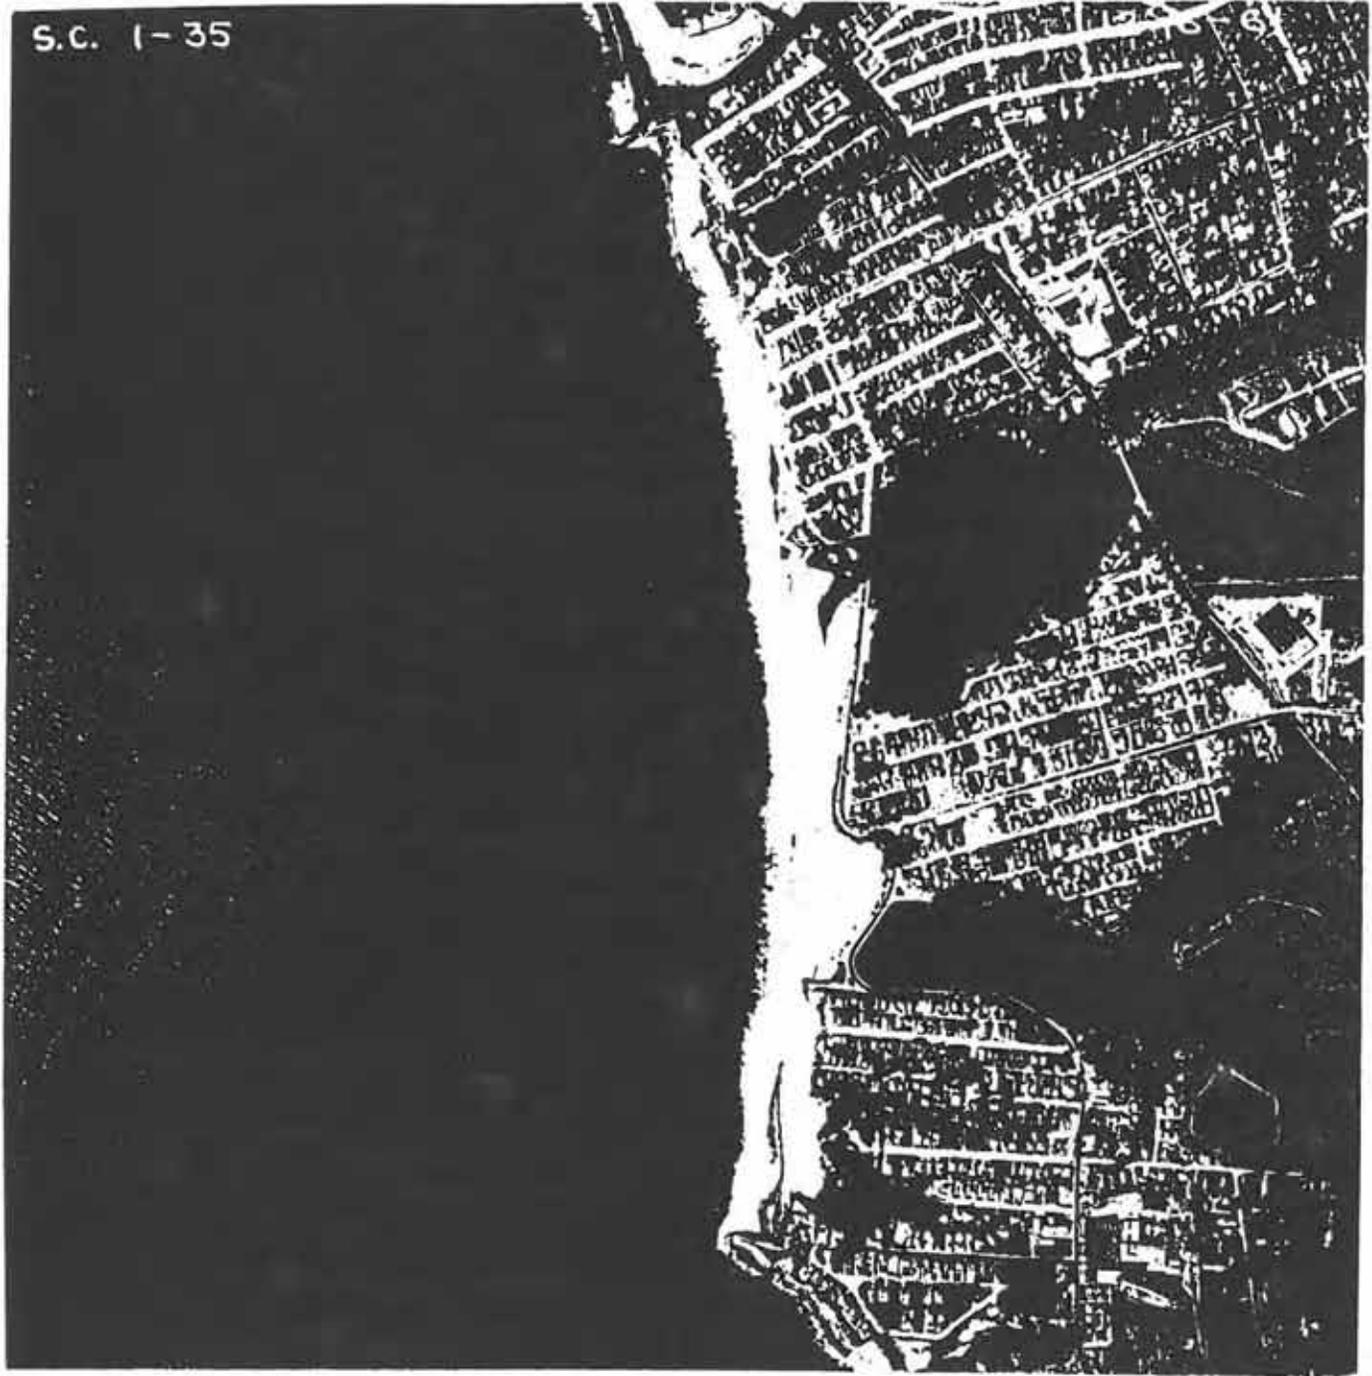
Figure 3. The coastline between San Lorenzo Point and Black Point in December 1961 prior to harbor construction.

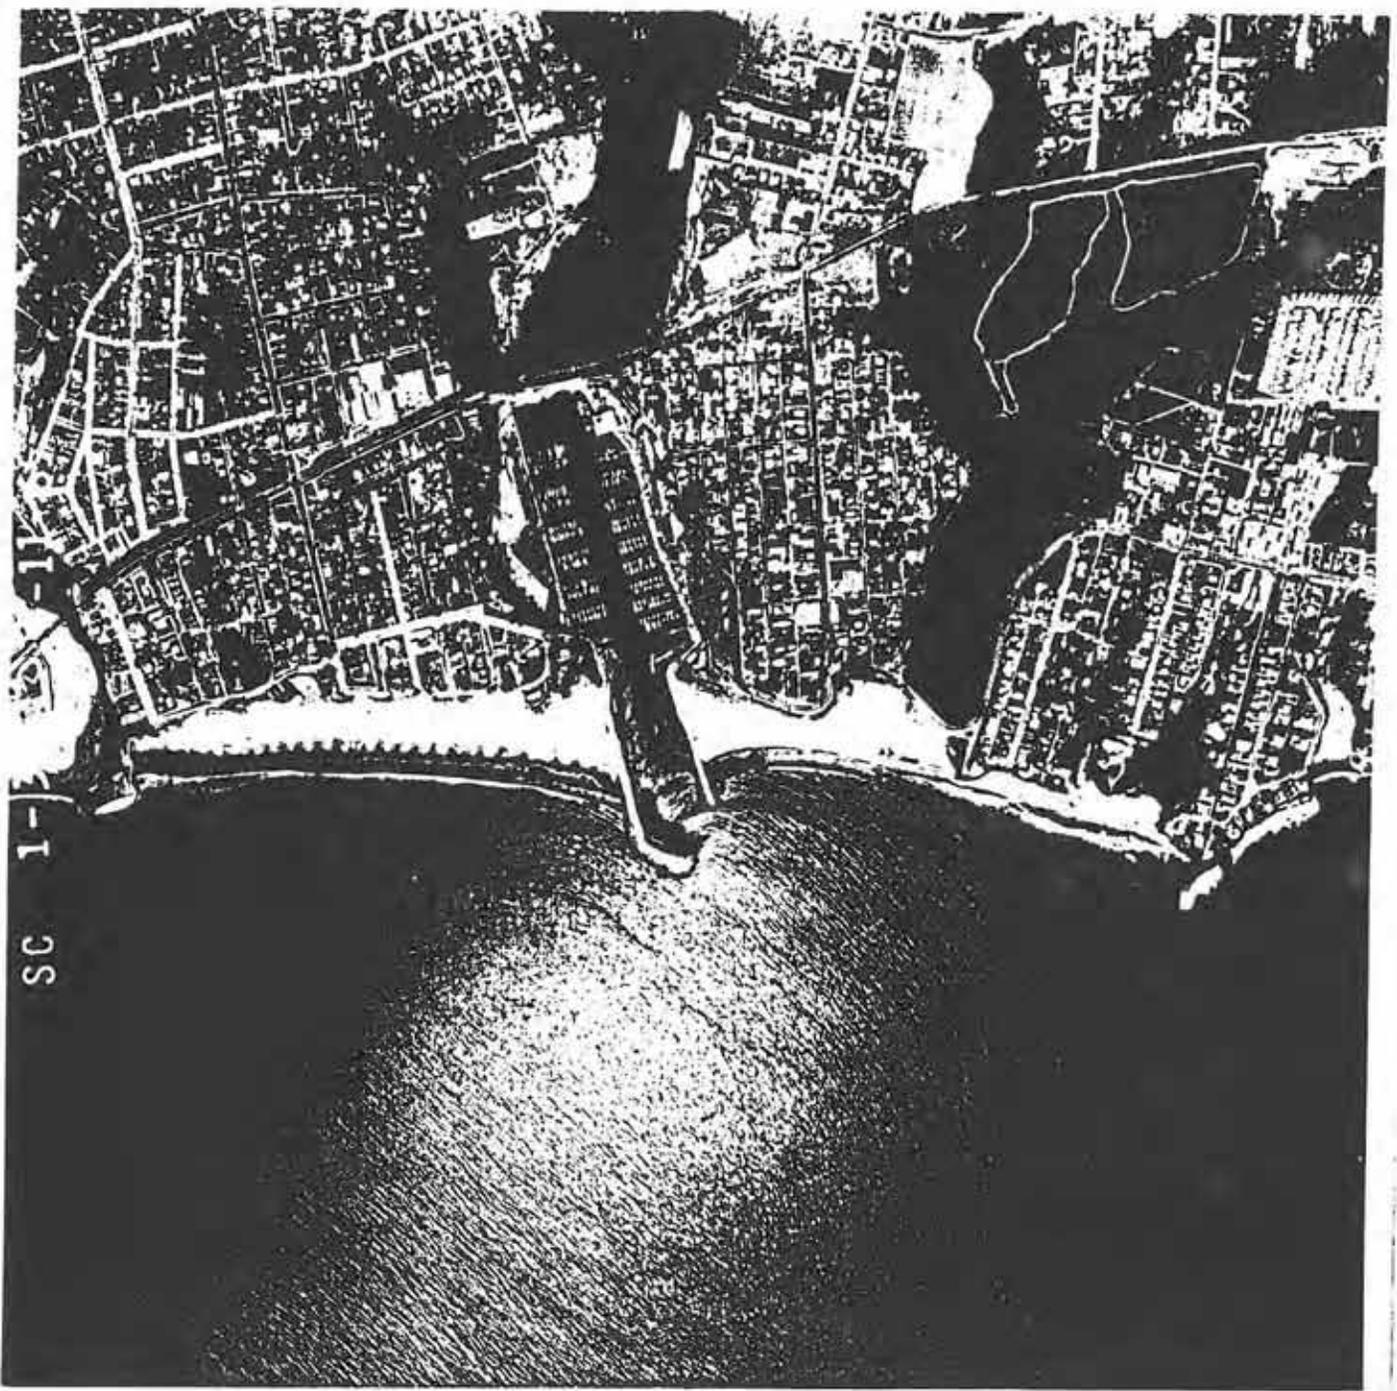
Figure 4. Coastline between San Lorenzo Point and Black Point in May 1965 following harbor completion.
